eSTPE & Steam Path Audits

Summary of Steam Path Audit Graphs

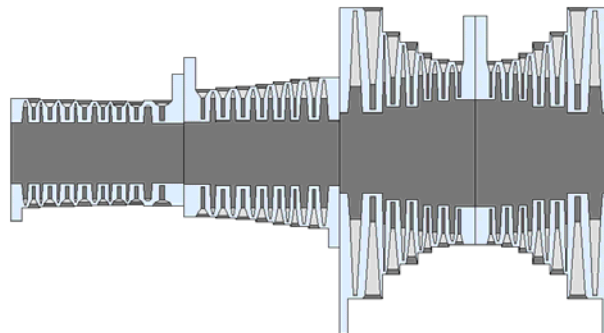
A. These graphs provide graphical methods to review casing clearance trends and to check input data. An example of a trend that would be quickly recognizable from the clearance graphs is an increasing clearance on the bottom or top of a casing, even though the left and right sides of the casing may show no significant deviation in clearance. The graphs also provide a check for data that does not fit the trend. If the stages of a casing follow a trend, but one piece of data does not seem to fit, the data can be reviewed to assure correct measurement and input of that data.

In eSTPE, the user enters the left and right clearances at the horizontal joint, tooth heights around the circumference of the packing, and ellipticity and spring measurements, to get a better representation of the overall flow area than clearances alone can supply. The clearances at the top and bottom of the casing, because of rotor “rub” or erosion, may be significantly larger than clearances at the sides of the casing, which may be near design. As an example, if the packings in a casing have experienced a bottom rub during operation, the flow through that packing could be as much as 40 percent higher than the design due to increased clearance on just the bottom of the packing.

Patterns observed from the packing graphs show relative top-to-bottom and side-to-side wear patterns to help improve understanding of the cause of the wear, and the corrections that may be used to reduce packing wear in the future.
