TURBINE STEAM PATH AUDITS FOR IMPROVED PERFORMANCE AND PROFITABILITY

PAUL E. BABSON, DIRECTOR, BUSINESS DEVELOPMENT, ENCOTECH, INC., SCHENECTADY, NEW YORK

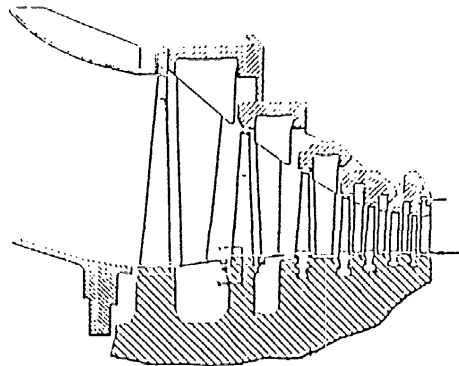
The steam path of a low-pressure utility turbine with reaction blading is shown in Figure 1. The condition, from a

FIGURE 1 IMPULSE TURBINE STEAM PATH

performance point of view, of all components and their surfaces that serve to

contain, control, and direct the steam flow and to extract energy is subjected to scrutiny and evaluation by the performance audit engineer. It is in this area, and any structural support mating surfaces surrounding these areas, that the audit engineer concentrates the survey.

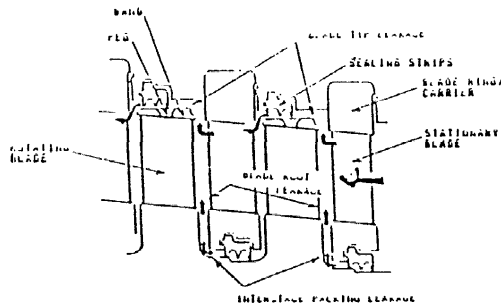
As shown in Figure 2, the blade ring carrier supporting the stationary blades between each set of rotating blades has a packing next to the rotating shaft to control interstage leakage of steam. Without this packing, the flow of steam around the stage blading would be excessive and would seriously degrade the performance of the turbine.

FIGURE 2 REACTION DRUM ROTOR CONSTRUCTION

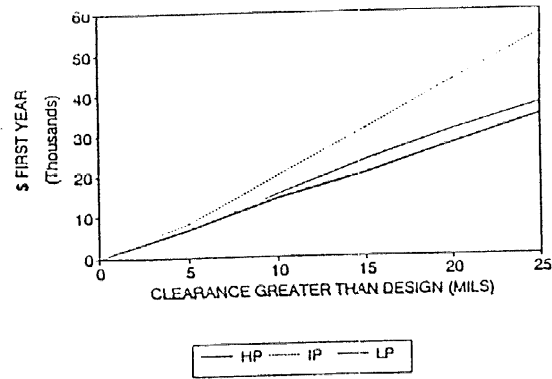
Figure 3 shows the annual fuel penalty incurred for progressively greater-than-design interstage packing clearances on a 300 MW unit. The three curves shown are additive for the entire three casing electric utility unit selected for this example. A typical cogeneration unit would be represented by the LP (low pressure turbine) curve. These are

FIGURE 3 INTERSTAGE PACKING WEAR EXCESS RADIAL CLEARANCE

significant dollar amounts that have a direct impact on profitability.

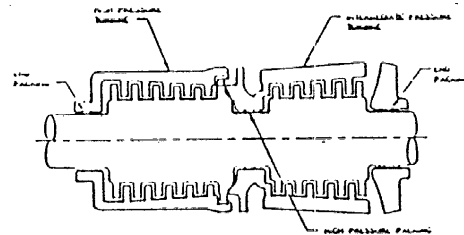
End (dummy) packings, as shown in Figure 4, control leakage between casings or to or from the atmosphere. Figure 5 is a plot of the increased fuel cost penalties that would result from clearances progressively greater than design.

FIGURE 4 END PACKINGS SCHEMATIC DIAGRAM

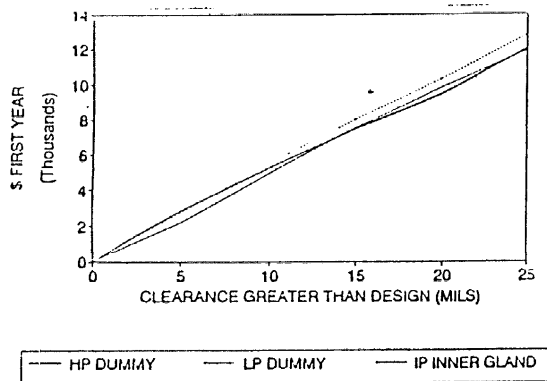
FIGURE 5 PACKING WEAR
EXCESS WEAR

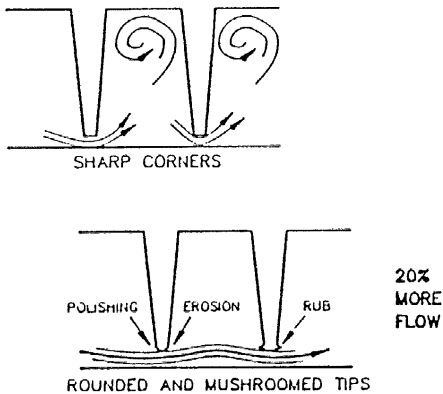
Figure 6 illustrates the effectiveness of rounded versus sharp packings. A rounded tooth, whether the result of a rub or erosive wear, will incur up to 20% increase in leakage for the same clearance. Because of this, normal maintenance should prioritize the sharpening of packing teeth at every opportunity. Figure 7 shows the increased fuel cost penalties associated with both rounded and sharp teeth having progressively greater clearances for a

FIGURE 6 EFFECT OF TOOTH SHARPNESS ON FLOW

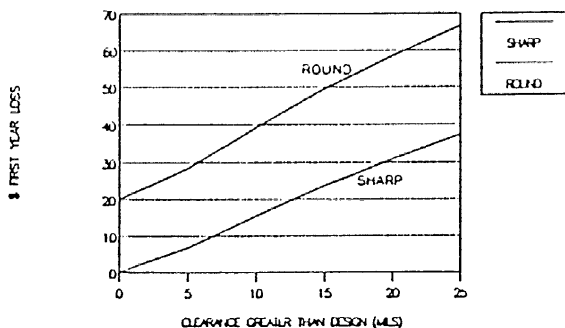
Round Vs Sharp for HP Casing

FIGURE 7 PENALTIES RESULTING FROM
INTERSTAGE PACKING WEAR

high pressure utility turbine interstage packing.

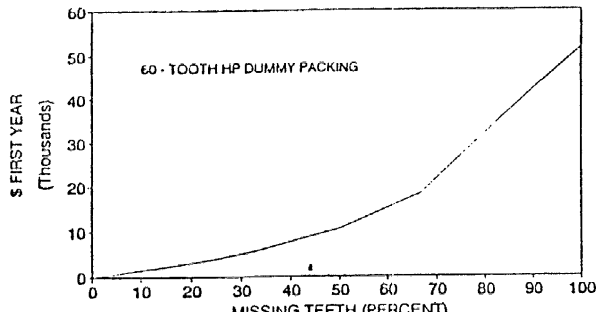
End packings have multiple teeth, and are therefore not as sensitive to individual tooth damage as are radial spill or other single tooth packings. Figure 8 shows the increased cost of fuel associated with progressively larger numbers of missing teeth for a typical end packing design.

FIGURE 8 PACKING TEETH
EFFECT OF MISSING TEETH

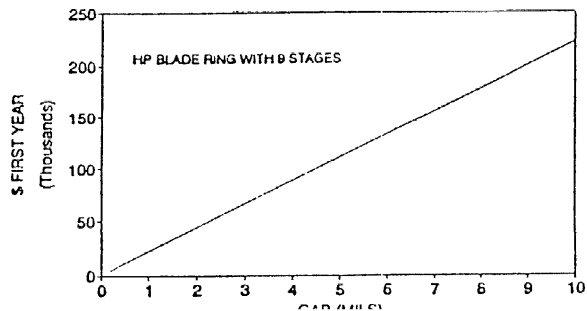
The total bypass of a group of stages is very costly in terms of lost performance. Figure 9 shows the increased

FIGURE 9 INNER CYLINDER RING FIT
GAP BETWEEN BLADE RING & INNER SHELL

fuel costs associated with steam losses from this type of leakage. Fortunately, the penalties shown are for a continuous gap around the entire ring. The normal

defect is for a gap to occur around only a portion of the entire circumference, resulting in reduced losses. The audit engineer calculates the leakage flow area involved and the computer program proportions the losses accordingly. Because even these losses can be substantial, good workmanship in these areas can result in considerable savings.

Another leakage area that affects performance is at the locations where the blade ring carriers fit into the casings. These have dovetail joints that are prone to galling damage during assembly and disassembly and to warping in operation. When the fit does not seal, steam can bypass an entire blade ring.

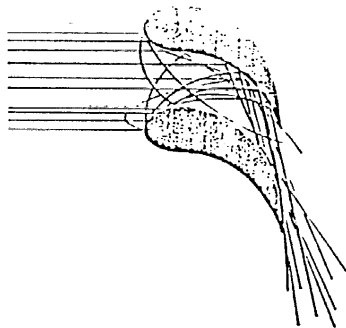
Figure 10 depicts the particle trajectories that can cause erosion

FIGURE 10 PARTICLE TRAJECTORY

damage. These trajectories are random, and the particles and their sizes vary according to their sources. They can come from the boiler and upstream piping and tend to be more prevalent during startups and cycling. They tend to centrifuge radially outwards and therefore erode spill strips as well as the blading. In the process, the spill strip particles and other debris adds to the downstream erosion.

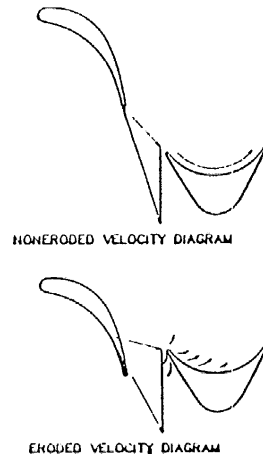
Figure 11 illustrates the detrimental effect that excessive erosion can have

FIGURE 11 VELOCITY DIAGRAMS

upon the velocity diagram of the blading. Figure 12 shows an eroded trailing edge of

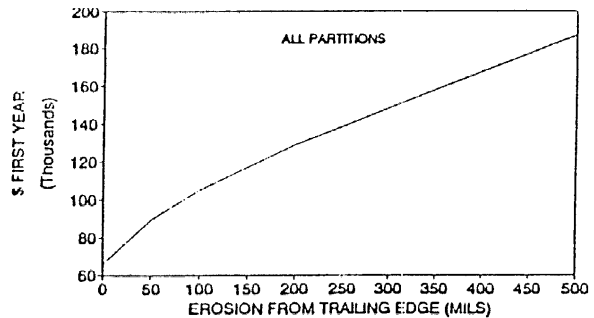
a blade. This erosion increases the flow area and again is very detrimental to the stage velocity diagram. Figure 13 shows the excessive fuel cost penalties associated with control stage trailing

FIGURE 13 SOLID PARTICLE EROSION DAMAGE TO CONTROL STAGE

edge erosion. As partitions do not usually wear symmetrically, the audit engineer again proportions these costs accordingly by inputting the appropriate wear severity into the computer program.

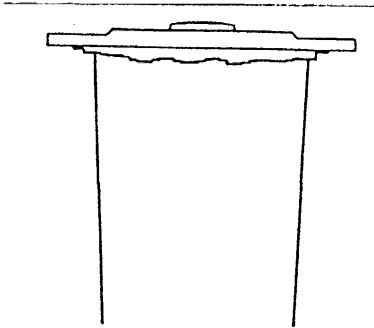
Figure 15 illustrates a buildup of erosion particles under a rotating blade

FIGURE 15 DEPOSITS UNDER SHROUD COVERS

cover. These built-up deposits cause a flow disturbance in the rotating blade flow for a small radial distance, which is costly in terms of performance loss. These buildups should be carefully removed without damaging the surface finish of the blade or cover.

Removal of the particles can be demanding, because the build-up is mostly due to the centrifuging action of the rotating blades upon the particles in a steam environment, causing a surprisingly

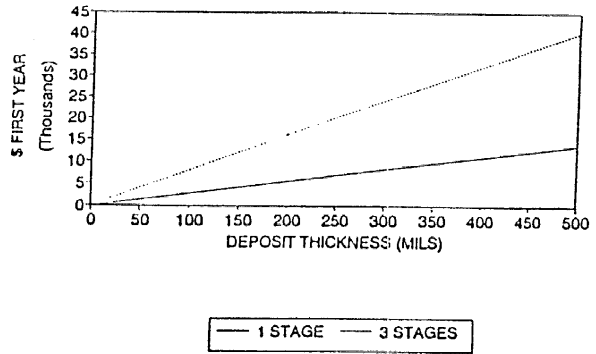
dense accumulation firmly bonded to the inside surface of the covers. Figure 16 is a plot of fuel cost penalties associated with progressively larger buildups of solid particles.

FIGURE 16 COST PENALTIES DEPOSITS UNDER SHROUD COVERS THICKNESS

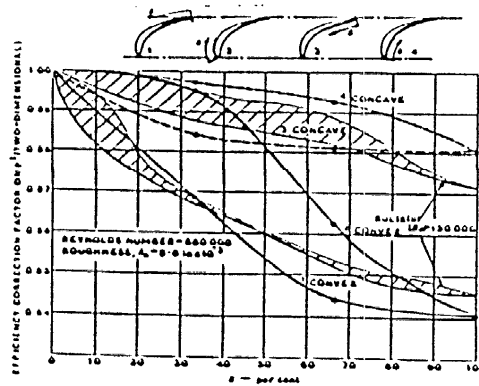
The surface finish of the blading has one of the greatest effects upon performance. Based upon the detailed and well documented work of researcher V. T. Forster, as shown in Figure 17, profi

FIGURE 17 EFFECT OF LOCAL ROUGHENING

efficiency is affected more by roughness on the suction surface of the blading than the pressure surface. Additionally, the trailing edge on both the suction and pressure surfaces is more sensitive to surface roughness than the leading edge. Figure 18 translates this loss into excessive fuel cost for an L-3 stage with a roughness Equivalent Sand Grain Size

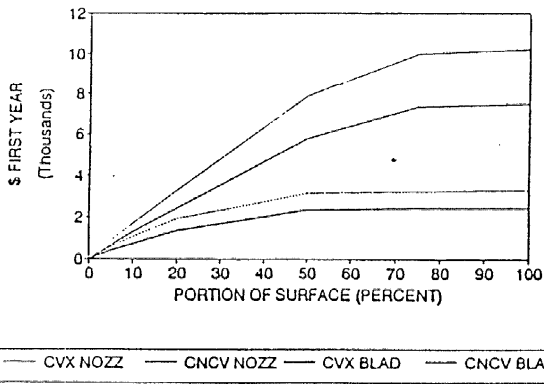
Stage L-3, ESGS = 1.0

FIGURE 18 SURFACE ROUGHNESS ON NOZZLES AND BLADES

(ESGS) of 1.0, a normal roughness for a turbine that has been operated for a few years. As stated above, the suction (convex) sides of both the rotating and stationary blades are the most sensitive to roughness.

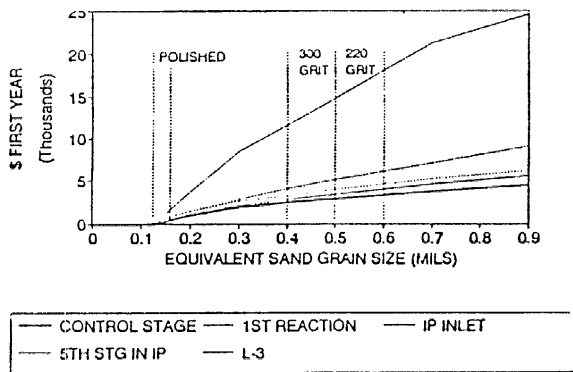
Figure 19 shows the fuel cost savings associated with the restoration of surface

FIGURE 19 SAVINGS FOR IMPROVING SURFACE ROUGHNESS OF A SINGLE STAGE NOZZLE TRAILING EDGE, CONVEX SIDE

finish on the trailing edge of a nozzle. The control stage is by far the most sensitive. When new from the factory, all surfaces are polished and deliver design efficiency. The normal surface finish restored to blade surfaces during overhaul with grit blasting is in the range of 0.4 to 0.6 ESGS. Restoration of surface finish at every opportunity is recommended, as it will result in significant savings.
